NASA MEMO 2-13-59E

EXPERIMENTAL EVALUATION OF CERMET TURBINE STATOR

BLADES FOR USE AT ELEVATED GAS TEMPERATURES

By Patrick T. Chiarito and James R. Johnston

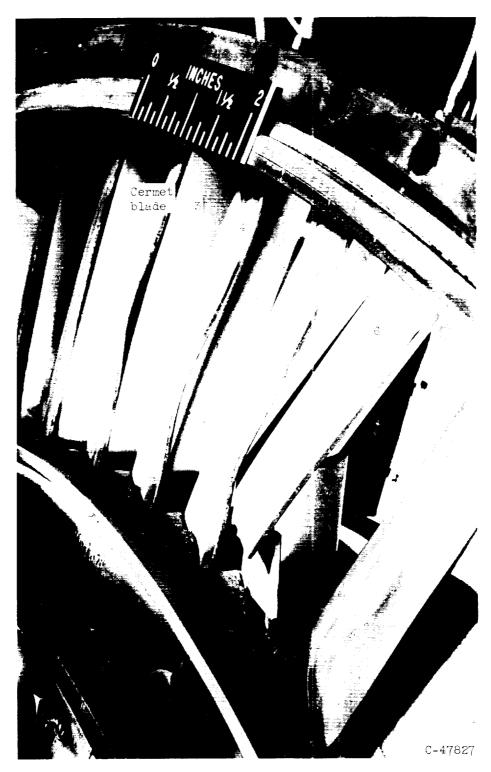
Before the start of test 3, three of the cermet blades had the desired looseness in the slots, but blade 6 (Mig. 7) was snug between the spacer bands. No attempt was made to remedy this condition. During the fourth inspection (after 37 hr and 35 min) the trailing edges of all cermet blades were found to be buckled. The depth of buckle was the

greatest in blade 3 and decreased to be the least in blade 6. Comparison between the turbine-inlet-gas temperature profile for this fourth test interval (fig. 10(a)) and the typical profile for a previous interval (fig. 10(b)) indicated an abnormal condition. There was a spread of about 800° F in the gas temperatures as compared with 500° F obtained during normal operation even though the exhaust gas temperature was maintained at 1260° F. The fuel nozzle in the hot combustor was found to leak at the upstream end, because the 0-ring made a poor seal. The resulting excess fuel supplied to this combustor probably caused hot gas streaks that might have contributed to the buckling of the trailing edges. Because the buckle in the trailing edge of blade 3 was downstream of the highest gas temperature measured (fig. 10(a)), it is reasonable to expect it to be the deepest - measuring about 3/16 inch. Likewise, blade 6 was downstream of the lowest temperatures measured and it buckled the least.

Blade 6, which was originally snug, was tight in the slots during the second and subsequent inspections until the fifth (after 46 hr and 45 min), when it was loose. During the next inspection after 52 hours and 15 minutes at rated speed, (including 11 engine starts) this blade was found to have fractured chordwise about 1/4 of the height from the inner band. No localized deformation was noted at the fracture. Figure 11 shows the fracture and the buckling of the trailing edges mentioned in the previous paragraph. There was no conclusive evidence that blade 6 was the most highly loaded cermet. It is likely, however, that this blade was subjected to end bending moments resulting from thermal distortion of the outer spacer band. Such loading is suggested because blade 6 was usually tight in the end slots during inspections, while the other three were not. End compression was unlikely because of the end clearance provided. Furthermore, this blade had the least capacity to deform because it was exposed to relatively cool gas. The resulting combination of high loading and low temperature, and the relatively rapid oxidation of the surfaces possibly caused the failure. Oxidation is discussed in the next section.

Fortunately, both pieces of the fractured blade 6 jammed against the adjacent blade 5. If one of these pieces had come loose, damage would most likely have spread to the turbine rotor blades and then to the other stator blades - expecially the remaining three cermets. In order to prevent such catastrophic damage to a service engine, some internal strut should be used.

Penetrant-dye inspection of the cermet blades revealed one additional crack at the inner end of blade 4. This crack started at the trailing edge of the core hole on the suction side and extended for about 1/2 inch in an approximately spanwise direction.

Figure 11. - Cermet blades after 52 hours and 15 minutes at an average gas temperature of 2000 $\rm F.$
